# **INDOOR AIR QUALITY ASSESSMENT**

**Lakeview Junior High School  
1570 Lakeview Avenue  
Dracut, Massachusetts**

Prepared by:  
Massachusetts Department of Public Health  
Center for Environmental Health  
Bureau of Environmental Health Assessment  
Emergency Response/Indoor Air Quality Program  
July 2004

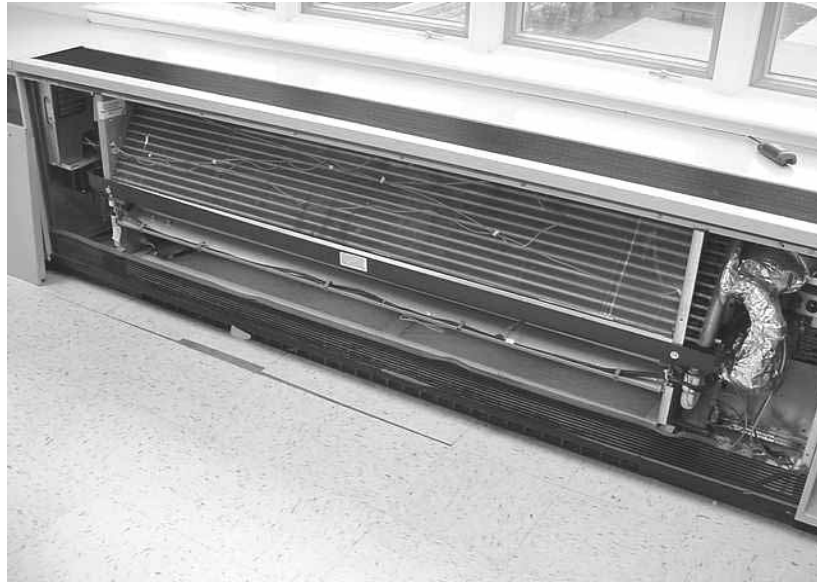
**Picture 1**

Fresh air in classrooms throughout the building is provided by unit ventilators (univents) (Picture 1). Univents draw air from outdoors through a fresh air intake located on the exterior walls of the building and return air through an air intake located at the base of each unit ([Figure 1](#)). The mixture of fresh and return air is drawn through a filter and heating coil and is then provided to the classroom via motorized fans through an air diffuser on the top of the unit. Univents were operating in all areas surveyed.

**Classroom Univent with Cover Removed**

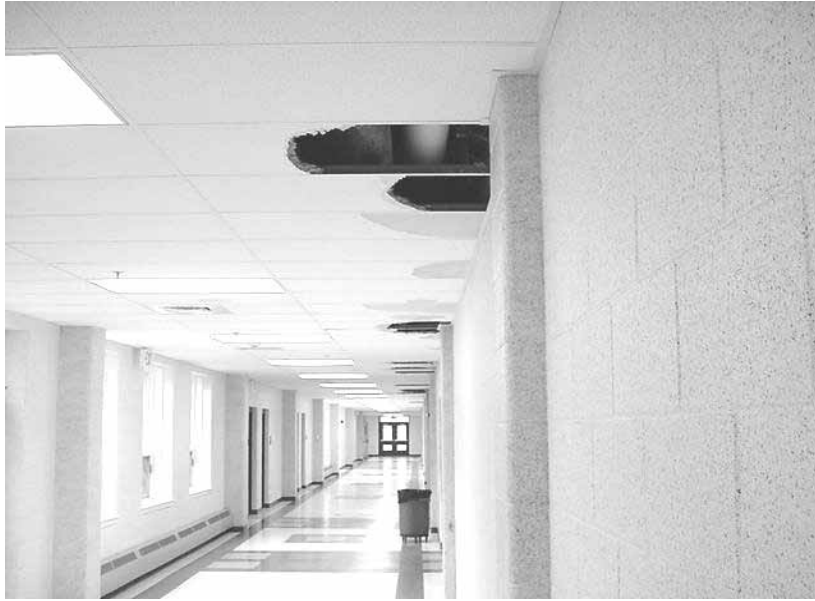
**Picture 2**

suspended ceiling tiles were dry and free of visible microbial contamination, despite a rainstorm that occurred 48 hours prior to the inspection that produced nearly 5 inches of rain in the Dracut, Massachusetts area (The Weather Underground, 2004). Extensive ceiling tile damage was noted in the hallway outside the cafeteria/gymnasium hallway (Picture 2), which was discovered on April 2, 2004. Damage to the ceiling tiles occurred overnight after BEHA staff left the building on April 1, 2004. The duration in which the cafeteria hallway ceiling tiles were moistened is not expected to be an adequate amount of time for mold to colonize the ceiling tiles. The US Environmental Protection Agency (US EPA) and the American Conference of Governmental Industrial Hygienists (ACGIH) recommends that porous materials be dried with fans and heating within 24 to 48 hours of becoming wet (US EPA, 2001; ACGIH, 1989). If porous materials are not dried within this time frame, mold growth may occur. Water-damaged porous materials cannot be adequately cleaned to remove mold growth. The application of a mildewcide to moldy porous materials is not recommended. Since these materials were not moistened prior to the reports of dermal irritation and were in a location away from the initial reports of skin symptoms, it is not likely that this damage is related to the rashes exhibited by students.

**Water Damaged Ceiling Tiles in Cafetorium/Gymnasium Hallway**

4. Discontinue the use of latex gloves to prevent latex dust generation.
  5. Identify and repair source of leak in the cafeteria/gymnasium hallway. Replace water damaged ceiling tiles. Examine the areas above and behind these areas for mold growth. Disinfect areas of water leaks with an appropriate antimicrobial.

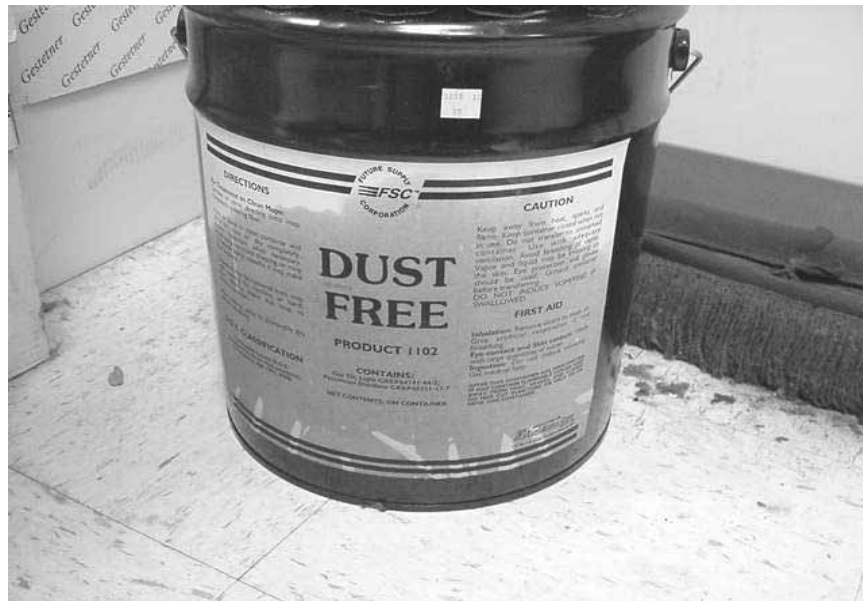
**Picture 3**

Indoor air quality can be negatively influenced by the presence of materials containing VOCs. VOCs are carbon-containing substances that have the ability to evaporate at room temperature. Frequently, exposure to low levels of total VOCs (TVOCs) may produce eye, nose, throat and/or respiratory irritation in some sensitive individuals. For example, chemicals evaporating from a paint can stored at room temperature would most likely contain VOCs. In an effort to determine whether VOCs were present in the building, air monitoring for TVOCs was conducted during the April 2, 2004 visit. An outdoor air sample was taken for comparison. Outdoor TVOC concentrations were non-detectable or ND (Table 2). Measurable levels of TVOCs were detected in the building after the floor was mopped with a petroleum based dust mop head treatment (Picture 3). These areas were retested several hours after the mopping and readings were ND. Therefore, it is also unlikely that the mop treatment was the source of the rash outbreak, particularly since it has been used in the school since the beginning to the school year without incident.

**Container of VOC-Containing Mop Head Treatment**

1. Use an alternative dust mop treatment that does not contain VOCs.
2. Reduce the use of cleaning materials that contain respiratory irritants (e.g. ammonia related compounds) on floors and in classrooms. Do not use these materials to disinfect equipment that comes into close human contact (e.g., telephones). Substitute plain soap and hot water for ammonia related cleaning

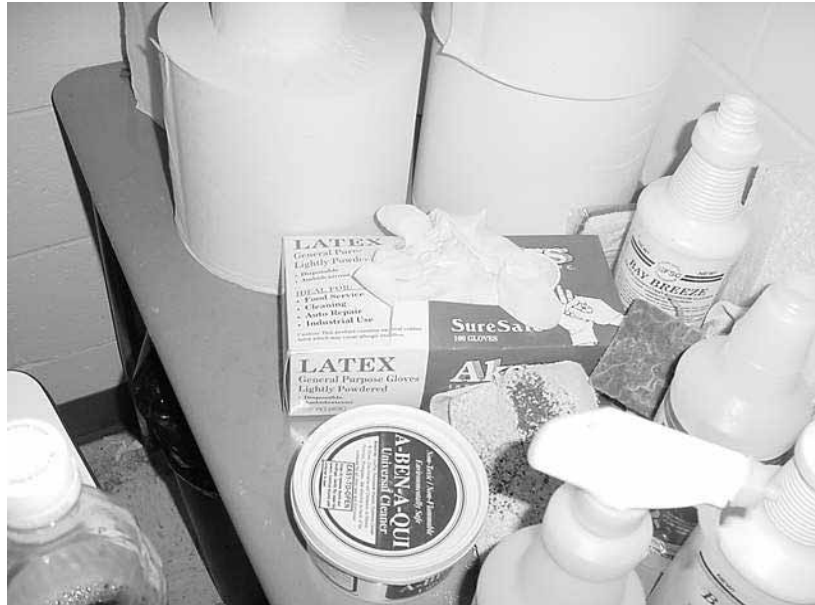
**Picture 4**

A number of other conditions that can potentially affect indoor air quality were also observed. Latex gloves appeared to be used by the custodial staff (Picture 4). Use of latex gloves may introduce latex dust into the school environment. Some individuals are highly allergic to latex (e.g., spina bifida patients) (SBAA, 2001). It is recommended that the use of materials containing latex be limited in buildings to reduce the likelihood of symptoms in sensitive individuals (NIOSH, 1997). A question and answer sheet concerning latex allergy is attached as [Appendix A](#) (NIOSH, 1998). While the presence of latex containing materials can produce symptoms in sensitive individuals, it is unlikely to be a cause of the rashes observed on students during this assessment.

**Latex Gloves**

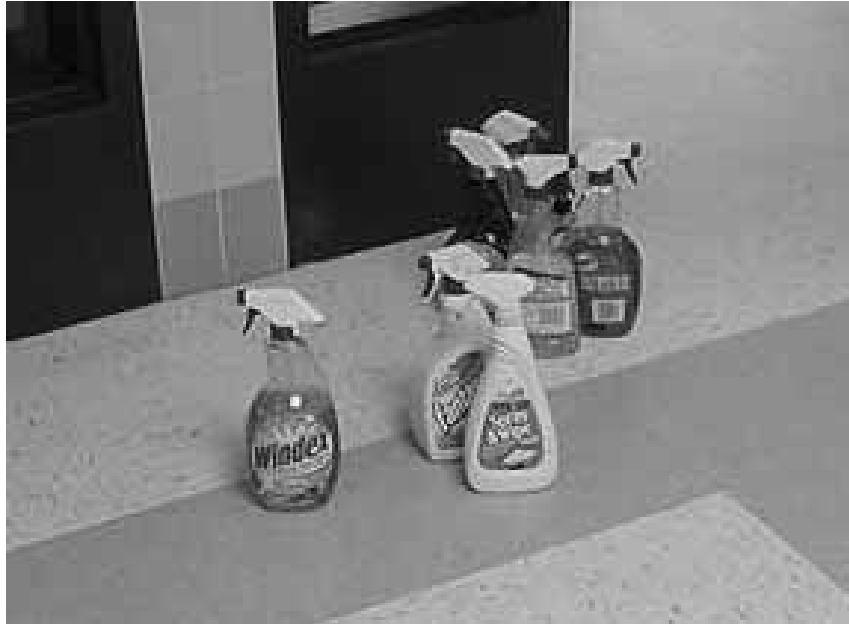
**Picture 5**

Finally, the use of individually purchased cleaning materials in the building was observed (Picture 5). Cleaning materials frequently contain ammonium compounds or sodium hypochlorite (bleach-products), which are alkaline materials. The use of these products can provide exposure opportunities for individuals to a number of chemicals, which can lead to irritation of the eyes, nose or respiratory tract. While the presence of

alkaline cleaning products can produce symptoms in exposed hypersensitive individuals, it is unlikely to be the cause of the rashes observed among students during this assessment.

**Individually Purchased Cleaning Materials Removed from One Classroom**

- products. Cleaning products that contain ammonia should only be used where necessary. If ammonia containing cleaning products is used, rinse the area of application with water to remove residue.

6. Obtain wall-mounted digital carbon monoxide detectors for the cafetorium and gym.
  7. Store cleaning products properly and out of reach of students.
